Manhole Inspection Summary

Manhole # S330__020MH

Insp Date: **8/21/08 1:49 PM**

Location Address: **250 s howard st**

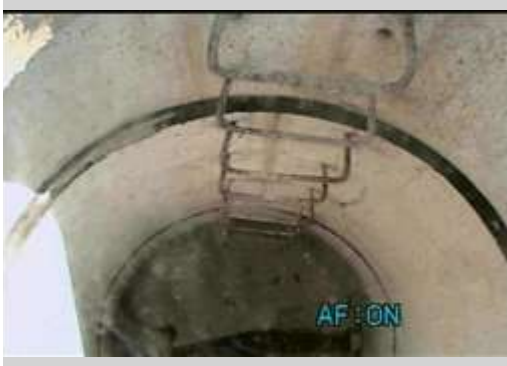
Defect 2

Steps Count: **7** Missing: **0** ☒ **Corroded**

steps

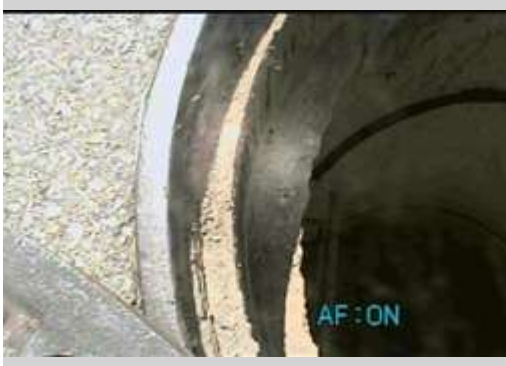
Defect 1

Frame Offset: **2** (in.) Condition: ☒ Sound ☐ Cracked ☐ Leaks

offset

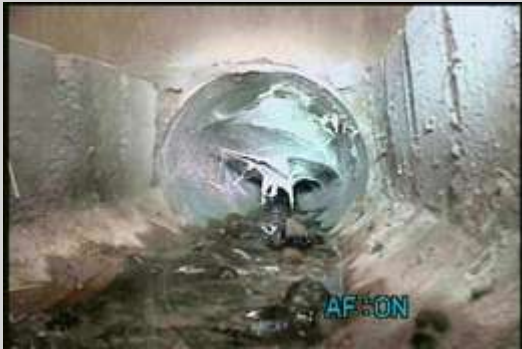
12 O'Clock Outflow

8 in. Circular Gravity Sewer
Pipe Out @ 12 O'Clock

Invert Depth: 10.00 (ft.) Flow Characteristics: None

Infiltration: None

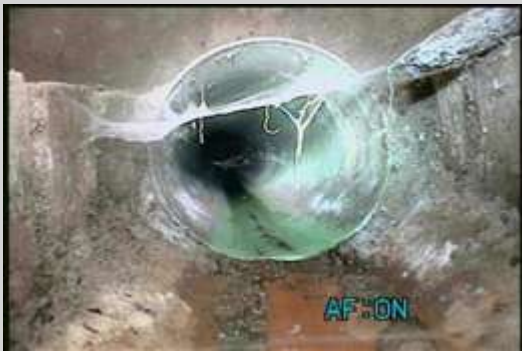
5 O'Clock Inflow

8 in. Circular Gravity Sewer
Pipe In @ 5 O'Clock

Invert Depth: 9.83 (ft.) Flow Characteristics: None

Infiltration: None
